AFRL-RX-TY-TR-2012-0077

## **EVALUATION OF LIQUID DETERGENTS AND METHODS USED FOR AIRFIELD RUBBER REMOVAL**

Brian W. Cotter, Jeffrey C. Petermann, Julie M. Heiser, Scott C. Smith

**AIR FORCE RESEARCH LABORATORY  
MATERIALS AND MANUFACTURING DIRECTORATE**

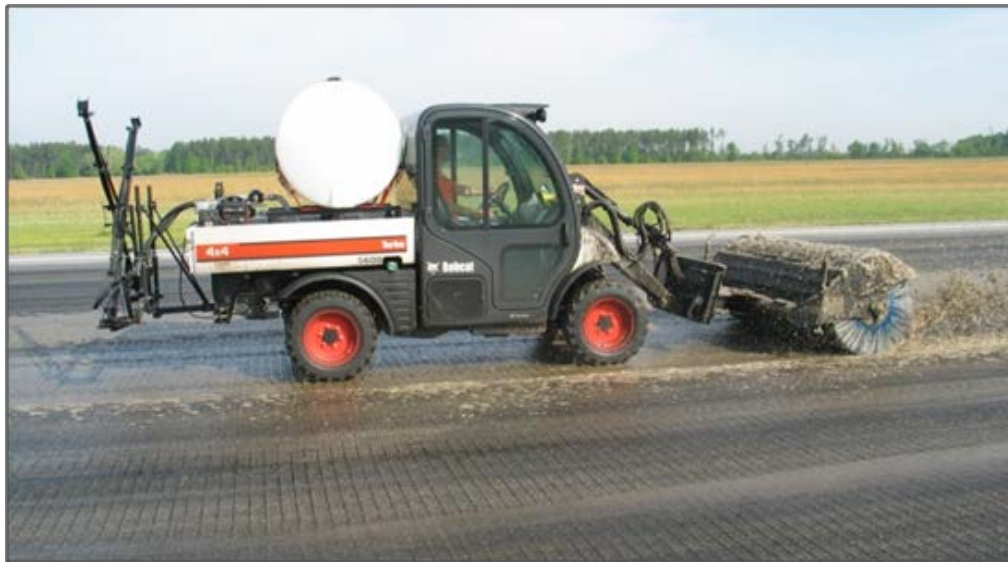
**Figure 1. Hydraulic Broom Attachment Agitating Detergents**

Each detergent test area was mechanically agitated and scrubbed for varying time periods as outlined in the original test plan. A diesel powered Toolcat<sup>®</sup> with a hydraulic kick broom attachment was used to forcefully remove the loosened and dissolved rubber material from the impacted voids.

The Toolcat<sup>®</sup> (manufactured by Bobcat<sup>®</sup>) is chosen for testing because of its versatility and size. The Toolcat<sup>®</sup> and all necessary ancillary items can be loaded on one C-130 aircraft. The Toolcat<sup>®</sup> is easily maneuverable in and around confined areas and has a top speed of 18 mph. A front-mounted kick broom attachment (Figure 1) and rear-mounted spray system can operate simultaneously or independently, depending on the operational needs during the rubber removal process. It also offers an enclosed cab which shields the operator from detergent misting and foreign debris.

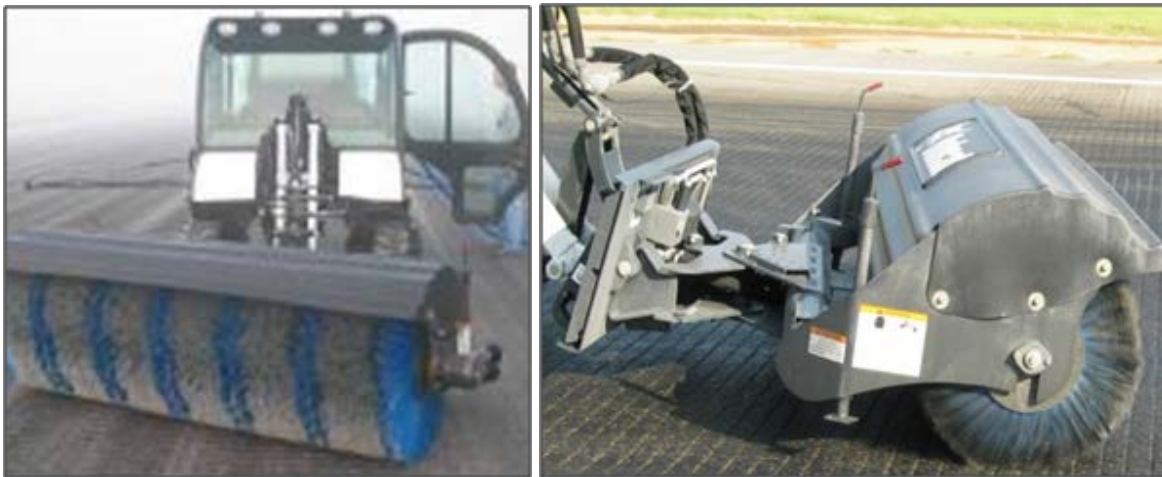
**Figure 2. Hydraulic Rotary Broom Attachment**

The following list details the broom equipment and applicable dimensions:

- Model: 84-inch Angle Broom (Bobcat<sup>®</sup>)
- Hydraulic Drive: 15–28 gal/min hydraulic direct drive
- Broom Angling Function: Hydraulic
- Operating Weight: 944 lbs (428.2 kg)—standard 50 wafer bristle configuration; 1060 lbs (480.8 kg) - recommended 90 wafer bristle configuration
- Bristle Diameter: 10.0 in (25.4 cm) inner diameter, 32.0 in (81.3 cm) outer diameter
- Overall Dimension: 61.0 in (154.9 cm) long; 96.8 in (245.9 cm) wide

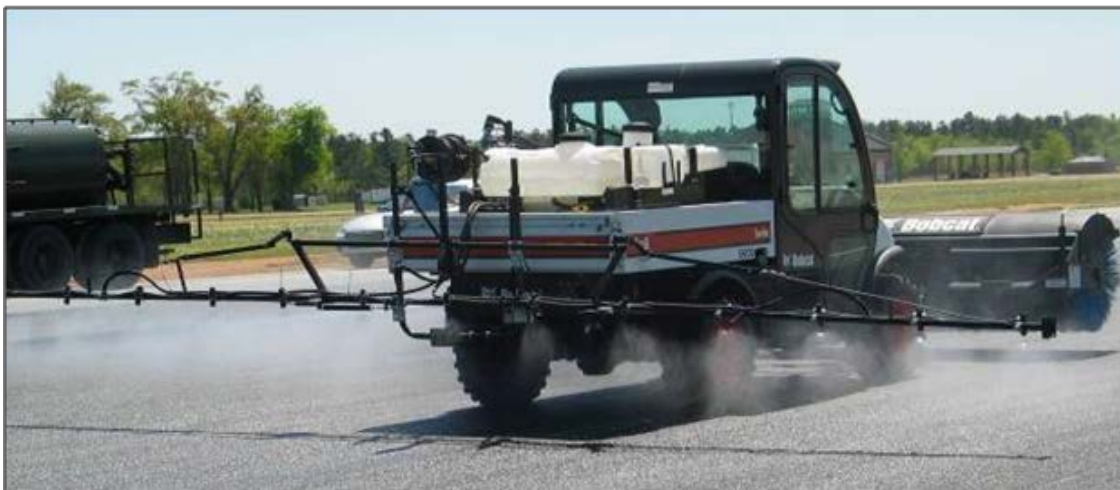
**Figure 3. Toolcat<sup>®</sup> Applying Detergents with 21-ft Spray Bar**

The detergent application system has two main components: a pumping mechanism and a spray bar attachment. During the experiment, two different pumping mechanisms were used: a gasoline-powered pump and a hydraulically-driven system powered by the Toolcat<sup>®</sup> vehicle. The hydraulically-driven system malfunctioned and was replaced throughout testing by the gasoline-powered pump. Each system delivered the chosen detergent from an on-board holding tank to a 21-ft collapsible spray bar attachment as shown below in Figure 3.

The spray bar consisted of 13 nozzles spaced evenly across with maximum operating pressures of 50 psi each. The flow rate exiting the nozzles remained consistent and applied coverage is determined by the forward speed of the Toolcat<sup>®</sup>. Because coverage requirements differed by detergent, the forward speed of the Toolcat<sup>®</sup> was adjusted to compensate. Detergent application will be discussed in greater detail later in this report.

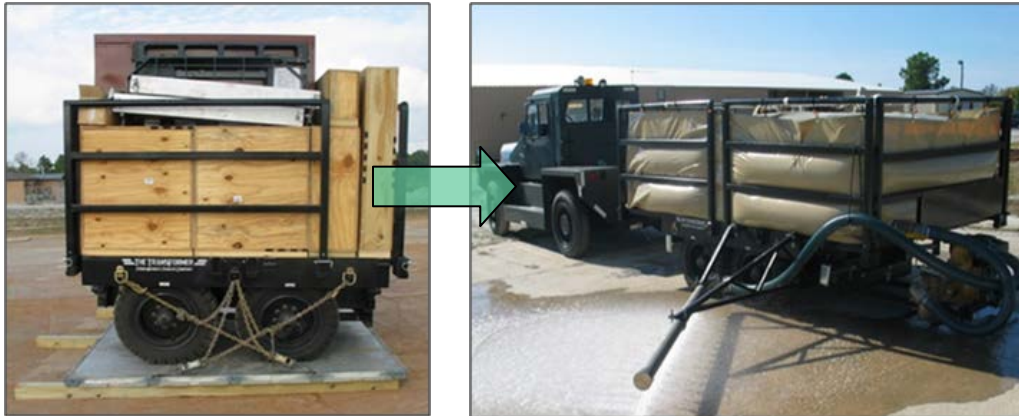
**Figure 4. Water Rinse Trailer—Travel Mode to Full Assembly**

To effectively remove applied detergents and loosened rubber from the airfield surface after cleaning, large quantities of water were required. Water sources are typically located long distances from the runway and water transportation to the cleaning site can be timely and cumbersome without proper equipment. Since all equipment included in this kit must be C-130 transportable, overall size is a constraint. To overcome the challenge of mass water delivery to the site, a transforming rinse-down trailer was developed to fit onto a 463L pallet for air transport.

Once on site, the trailer is transformed into its operational state as shown in Figure 4. A 2,000 gallon nylon bladder is placed into the expanded trailer bed which can be filled to capacity within minutes using a local fire hydrant. The bladder valve is connected to a series of flexible pipes that lead to a gasoline-power water pump attached directly to the trailer infrastructure. The outflow of the pump is piped to a rigid metal spray bar assembly mounted on the port trailer side. The spray bar assembly consists of 16 independent nozzles oriented at approximately 30 degrees forward from vertical to produce a “sweeping effect” wave motion which efficiently flushes loosened rubber and all remaining site debris from airfield surface. Each nozzle operates at approximately 35 psi with a nominal total flow rate of 250 gal/min across the bar.

The rinse-down trailer system produces enough volume and pressure to sufficiently remove the loose rubber particles and dissolved slurry, while neutralizing the highly basic nature of the detergent compounds and eliminating environmental impacts.

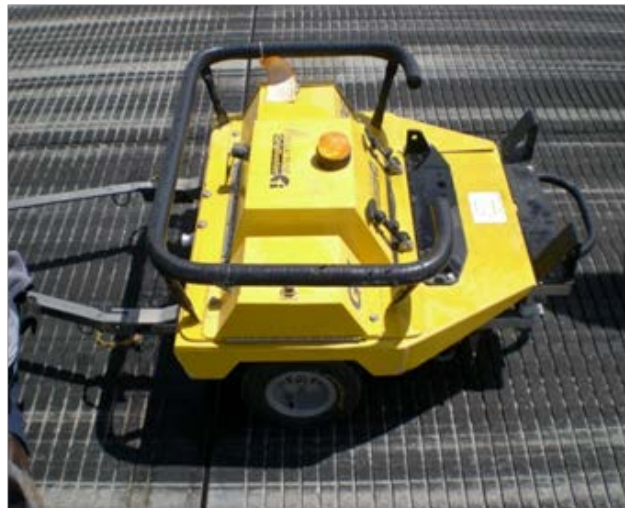
**Figure 5. Findley-Irvine GripTester Device**

The friction data is collected and compiled using a Findley-Irvine GripTester CFME device provided by the Air Force Civil Engineering Support Agency (AFCESA) as shown in Figure 5. The device can be towed behind any ½-ton (or larger) vehicle with adequate storage capacity for a metered water delivery system and equipped with a receiver hitch. The GripTester unit records real-time friction coefficients of the airfield pavement surface.

This CFME device is a lightweight, three-wheeled trailer which weighs 183 lb (83 kg) and is operated using a single, smooth tread tire that is mechanically forced to slip at 14.5 percent of the relative trailer forward speed. The differential slip is controlled by a calibrated, chain-driven transmission directly linking the skid tire and the main wheel axle.

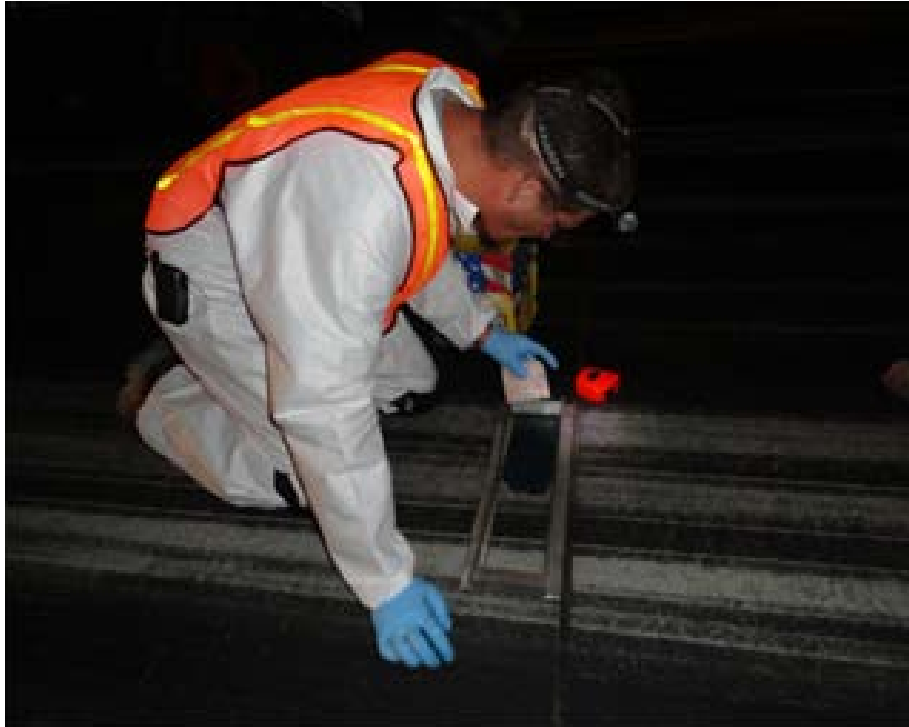
**Figure 9. Grease Application within Template**

Additional texture measurements were obtained from the airfield surface using the National Aeronautics and Space Administration (NASA) Grease Smear Method. This method determines the overall texture depth of the pavement surface by forcing a finite volume of grease into the macro-texture over a specified coverage area [3]. Grease smear tests were completed during both pre- and post-cleaning friction evaluations for comparison. Twelve smear tests were performed on each side of the runway within the test area at an offset distance of 7.5 ft from centerline. Testing began at a distance of 1,025 ft from primary and test locations were longitudinally spaced apart at distances of 75 ft. A total of 48 grease smear tests were performed overall. For purposes of direct comparison and determination of removal effectiveness, post- cleaning smear tests were placed in the exact location as the pre-cleaning routine.

For visual reference, Figure 9 illustrates the application process. A specialized metal template 4-in wide was placed onto the airfield surface in its pre-determined test location. A measured volume of 15 cm<sup>3</sup> of grease was placed via syringe onto the pavement surface within the template boundaries. The grease is smoothed across the pavement surface using a proprietary blade and nominal hand pressure to a uniform depth until all available grease has been depleted into the underlying texture voids. The smear length is then measured to the nearest quarter inch and recorded for future reference. The measured length of the smear is directly proportional to the overall texture depth within the template area; a greater texture depth yields a shorter smear length. Pre-cleaning smear test data is finally compared to post-cleaning data from the exact same location within the test area to obtain a percentage difference for analysis.

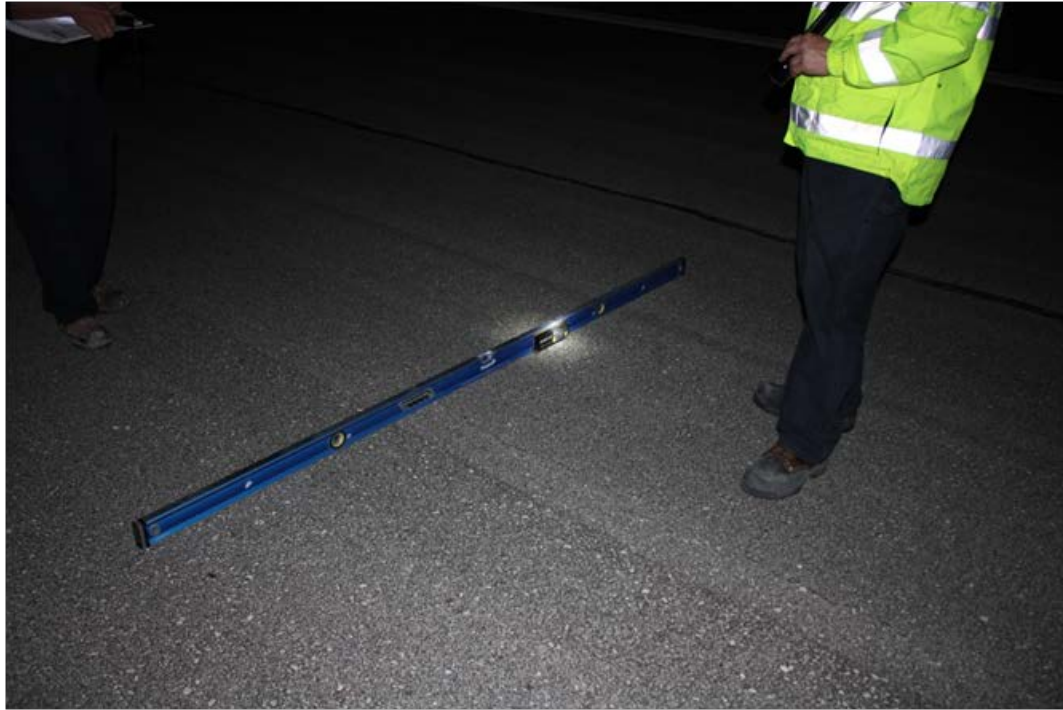
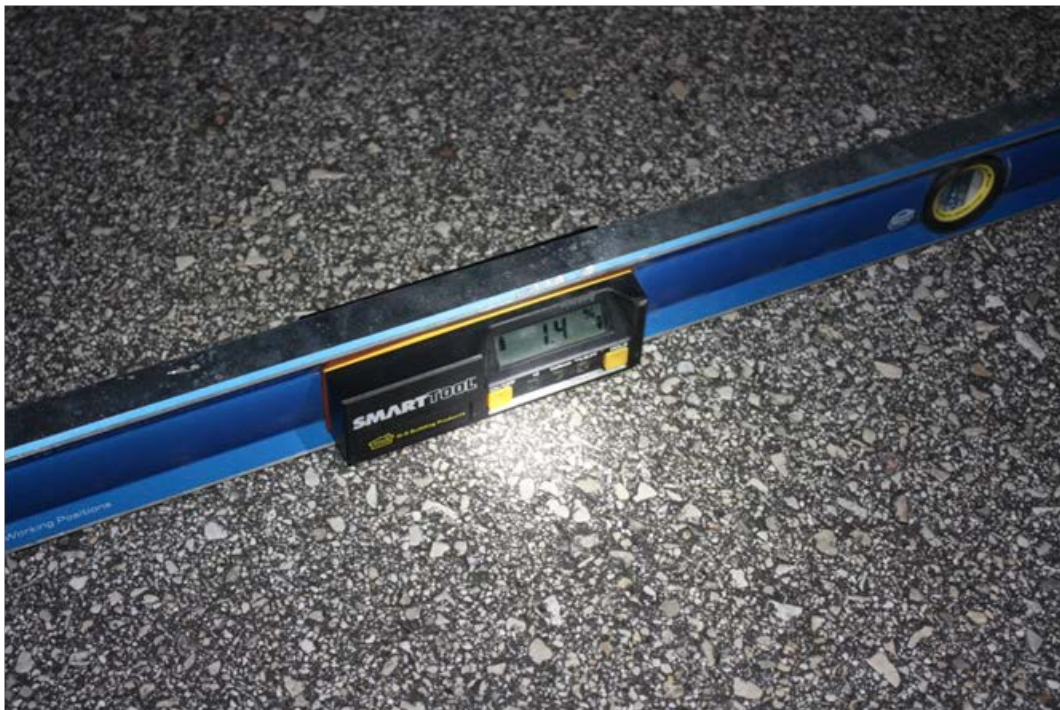
**Figure 10. Slope Measurement**

**Figure 11. Slope Measurement Reading**

Runway slopes were measured prior to friction analysis and rubber removal. These measurements were taken to identify ponding issues that could adversely affect friction. Two different slope measurements were recorded at each location; longitudinal and transverse. The longitudinal slope was measured along the runway centerline and the transverse slope was measured perpendicular to the centerline [5]. Figure 10 and Figure 11 show the slope measurement being measured in the field. The slope measurement field notes are located in Appendix A.

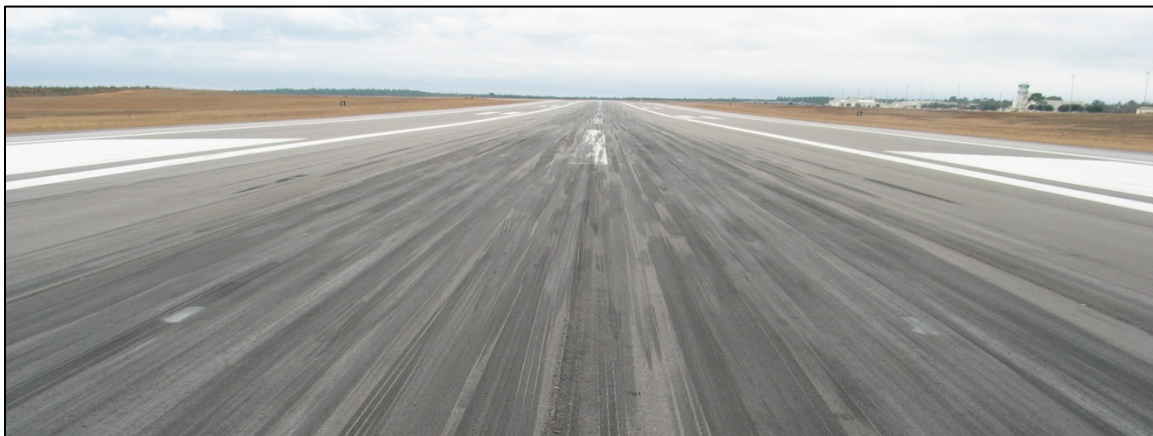
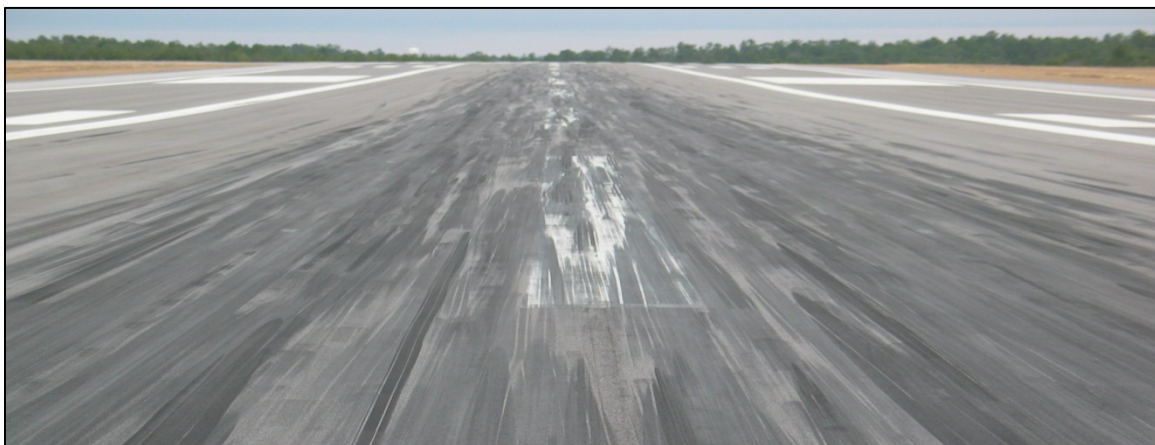
**Figure 12. Existing Test Site Rubber (18–36)**

**Figure 13. Existing Test Site Rubber (36–18)**

It must be noted that the airfield surface did not possess a significant amount of existing rubber build-up. The airfield has been recently re-surfaced and sufficient time had not yet passed to produce a level of rubber which neared the threshold of required cleaning.

The airfield as it existed prior to cleaning is shown in several photographs below. Figure 12 represents a view from the northern edge of the testing area facing south (18–36) and Figure 13 represents a view from the southern edge of the testing area, facing north (36–18).

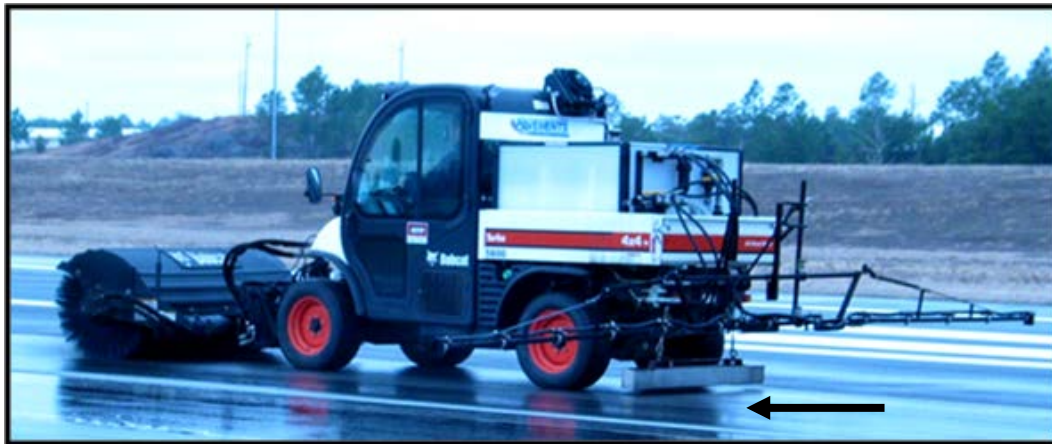
**Figure 16. Magnetic Bar Orientation on Toolcat®**

A magnetic bar was mounted via wired rope cables at the rear of the vehicle and oriented such that the magnet hung approximately one half inch above the airfield surface. Its purpose was to remove metallic FOD and broken wire broom bristles from the airfield during agitation. The magnetic bar is shown in Figure 16.

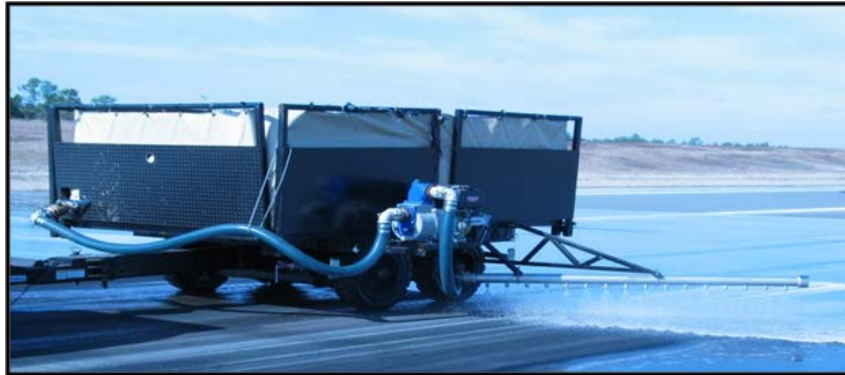
**Figure 17. Water Trailer Pump and Spray Bar Configuration**

The trailer was equipped with a water pump and spray bar configuration as seen in Figure 17. The pump is modified with a remote starting device which allowed the truck operator to start and stop the water flow as needed from the truck cab. The pump is checked for fuel and the spray bar

is checked for proper alignment and nozzle angle. The nozzles were set such that the water energy leaving the spray bar would hit the pavement surface at a 30° angle and produce a sweeping motion to literally push the detergent and lifted rubber debris along the airfield surface and out toward the pavement edge.

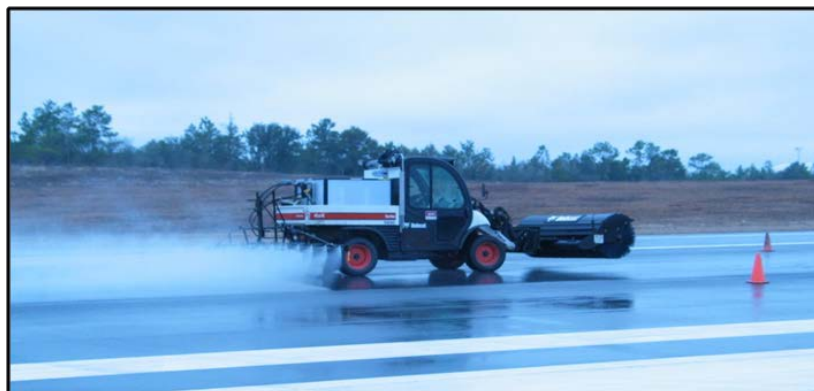
**Figure 18. Toolcat<sup>®</sup> Applying Detergents to Dampened Test Area**

To achieve uniform detergent dispersion, the Toolcat<sup>®</sup> is positioned such that the spray bar end travelled along the 50-ft edge from end to end as shown in Figure 18. This created a 21-ft wide swath width of detergent to the 30-ft wide test surface. The second pass is performed identically in the opposite direction and along the opposite long edge to ensure complete test area coverage. This method resulted in a 12-ft overlap, due to the test layout, of detergents in the test center, which is of little concern, as proper scrubbing patterns physically displace the detergent and spread it evenly throughout the assigned cleaning area.

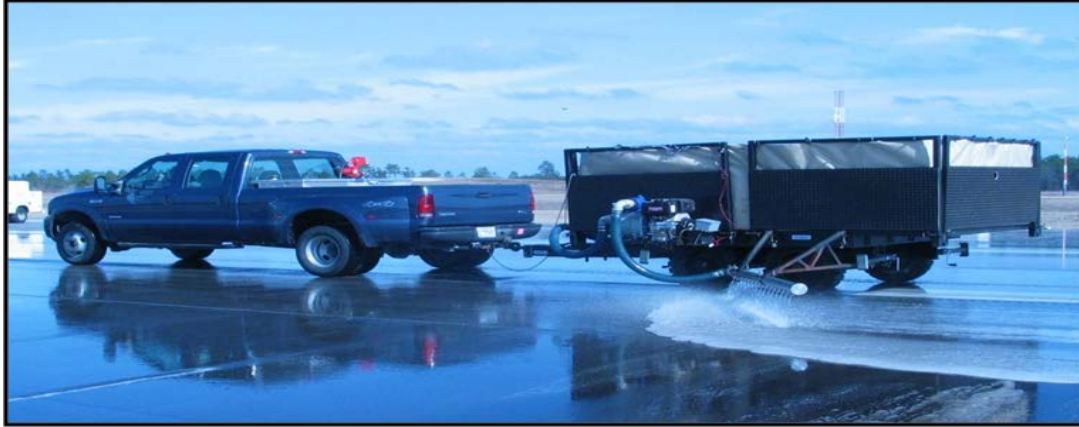
**Figure 19. Detergent Rinsing Technique**

The entire test area was thoroughly rinsed to remove the loosened rubber material immediately following the agitation effort; Figure 19 illustrates this process. The rinsing process also neutralized the detergent agents. The amount of water needed for this task was detergent dependent. Re-filling of the water trailer was required multiple times over the course of rinsing each test section.

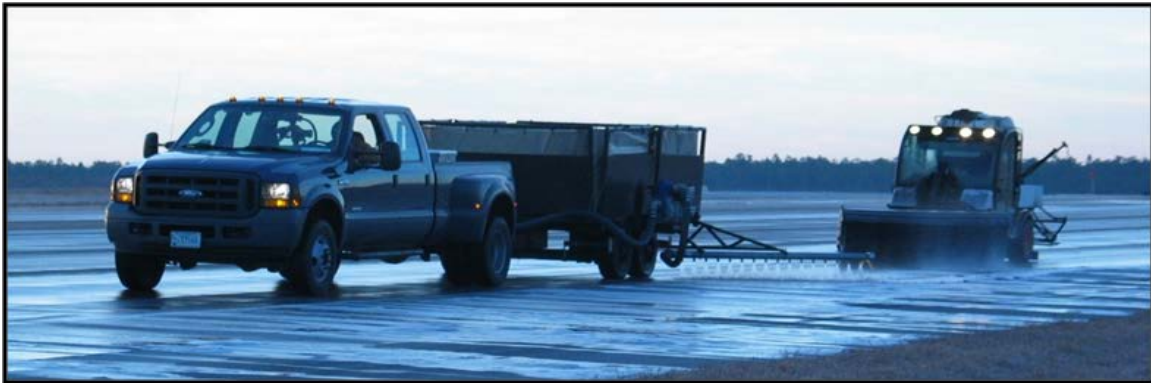
**Figure 20. Toolcat® Applying Detergents to Dampened Test Area**

The rinse procedure began at the centerline (or crown) of the airfield and worked outward in a growing pattern until all detergent and excess water had been pushed from the runway and onto the adjacent grassed area. The Toolcat<sup>®</sup> with broom attachment followed the rinse trailer to ensure removal of any foreign debris and standing water as shown in Figure 20.
